ADOSH ADVOCATE

Improving Workplace Safety and Health

Spring 2005

Point of Operation Guarding

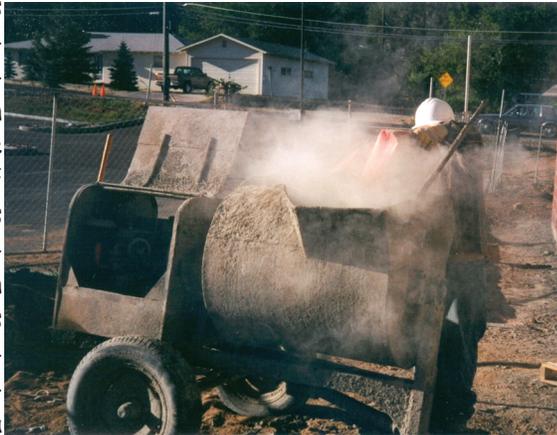
For the past year I have had the opportunity as a consultant to visit many construction employers who use portable cement mixers and air compressors that are powered by internal combustion engines. The guarding of the engine's rotating flywheels on these units has been consistently identified as a

point of operation hazard. OSHA Construction Standard CFR 1926.300(b)(4)(ii) is clear on this issue and states "The point of operation of machines whose operation exposes an employee to injury shall be guarded."

Manufacturers of motor driven cement mixers and air compressors have installed a rope start guard that covers the flywheel as a means of complying with this standard. However, due to the repeat starting of the units, damage sometimes occurs to the guard and it has to be removed. Unfortunately, employees do not usually contact their employer about the condition of the unit when the guards are no longer in place. As a solution, the employee oftentimes will leave the guard off and start the unit by wrapping a pull rope around the flywheel. This solution is the wrong one and must be eliminated. The employee can be injured by the exposed rotating portion of the flywheel. A machine in this condition should be removed from service and until the appropriate guard is installed.

to continue the practice of using a pull rope to start the unit provided that they cover the rotating portion of the flywheel with the cowl cover of the cement mixer. This again is an incorrect practice because the employee is exposed to the hazard when starting the unit and when lifting the cowl cover to turn the unit off. Employees should never be allowed to circumvent any guard that has been installed.
